Martin Slough Enhancement Project 2022 Monitoring Report

February 2023

Natural Resources Services Division
Redwood Community Action Agency
904 G Street
Eureka, CA 95501

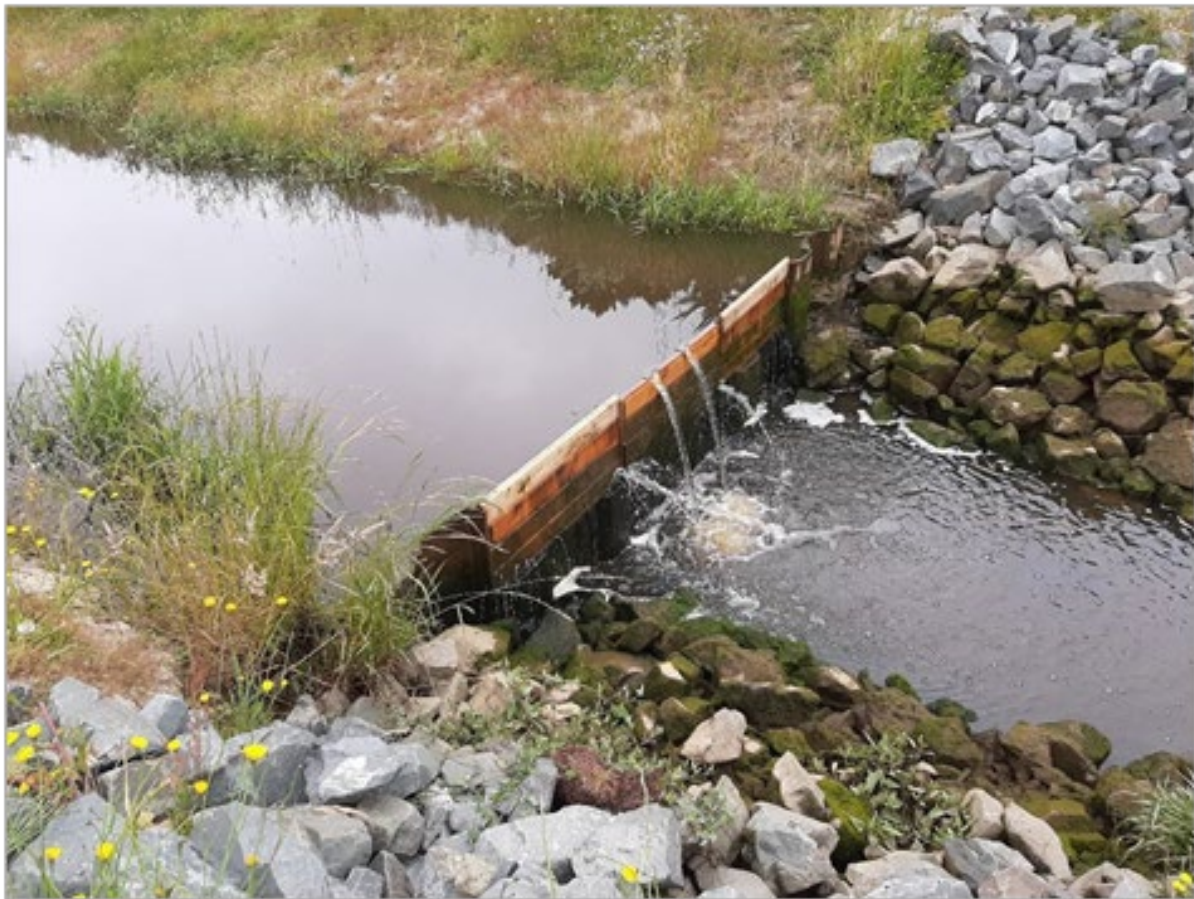
The EMGC currently diverts surface water from Martin Slough for irrigation of turf using their riparian water right. The irrigation diversion is in the North Fork channel of Martin Slough, approximately 265 feet upstream from the confluence with the mainstem. The water pumped from the channel originates from both the North Fork and mainstem of Martin Slough due to the low gradient of the slough and resulting backwatering of the pond from the mainstem. In mid-April, a temporary salinity barrier was installed in the mainstem just downstream of the confluence with the North Fork to isolate the municipal golf course irrigation intake from the tidal prism (Figure 2). At that time salinity in water pumped for irrigation was too high for watering greens and fairways. The salinity barrier was intended to allow for a year-round muted tidal regime downstream of the North Fork confluence with the Martin Slough mainstem following construction completion in 2021 (MLA 2022). The salinity barrier's intended operation period was the irrigation season with removal by the end of 2026, unless golf course irrigation system upgrades were completed beforehand.

Figure 2. Temporary salinity barrier installed to isolate the EMGC irrigation intake from the tidal prism. Located on the Martin Slough mainstem just downstream of the confluence with the North Fork.

North Fork. The salinity barrier affected the upstream hydrologic and water quality conditions. However, it did not appear to influence downstream water quality.

The water quality monitoring shows that water temperatures and salinity concentrations in the North Fork are exceeding the performance thresholds during summer and early fall. When the salinity barrier was in place, the salinity concentrations were within criteria, but the water temperature remained above the performance thresholds (Figure 3 above). The higher salinity concentrations are likely due to lower summer stream flows and more tidal-freshwater mixing than assumed during the design. Drought conditions resulting in below average stream flows during 2022 likely further influenced water quality. Adaptive management options to reduce salinity and water temperatures in the upper reaches of the project should be explored but appear to be limited at this time.

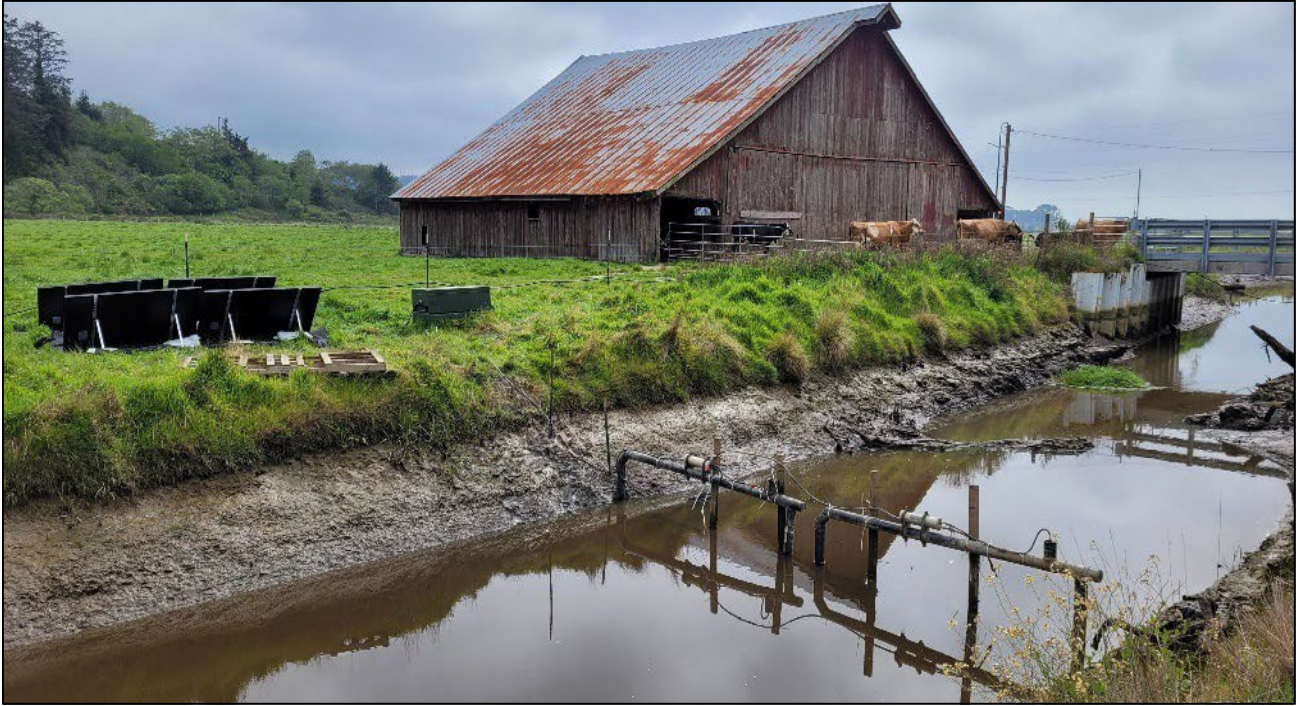
Another objective of fish monitoring was documenting the out-migration timing of coho salmon smolts in Martin Slough. A PIT tag antenna array and data logger system were installed in the lower reach of Martin Slough near the barn on the property owned and managed by the NRLT (Figure 5). This system consisted of a Biomark® IS1001 Multiplexing Transceiver system and two 10'x 3' pass-through antennas. The antennas were arranged side-by-side to cover the channel cross-section. This side-by-side arrangement provided better coverage of tagged fish migrating downstream, at the expense of having the antennas set above and below each other to detect direction of movement (direction is documented by a fish passing by one antenna and then the next antenna). All juvenile coho were tagged upstream of the array, therefore, all tag detections consisted of out-migrating coho smolts. Unknown tags or fish tagged in other Humboldt Bay drainages were assumed to be moving in an upstream direction through the array, having entered Martin Slough through the tide gate located approximately 1,200 feet downstream. The side-by-side orientation of the antennas provided better coverage during the wide variations in channel depth and width because of tide changes (Figures 5 and 6). Biomark® auto-tuned the antennas, which is important in a tidally influenced area with changes in water depths and salinity levels.

Figure 5. PIT tag antenna array system in lower Martin Slough at low tide on April 25, 2022.

Due to technical problems associated with electrical interference and delays in obtaining equipment to address the problem a fully functioning system with two antennas was operational by late April 2022, probably a month after the commencement of the coho smolt out-migrations. PIT tag detection data from the IS1001 unit were downloaded in approximately one-month intervals and the site was visited 2 or 3 times monthly to clear debris off the antennas and make sure the IS1001 unit was running properly.

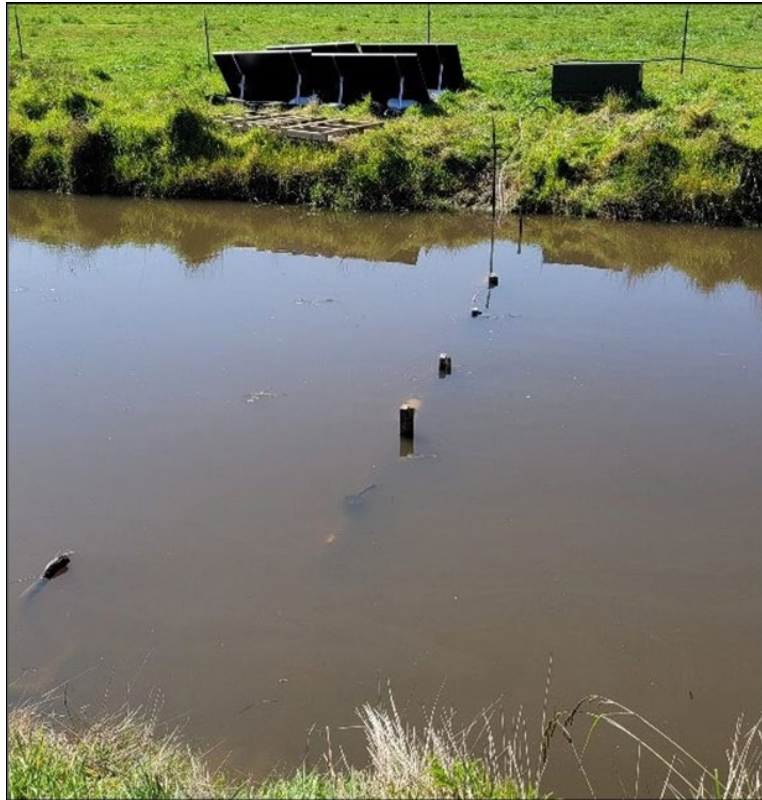
Figure 6. PIT tag antenna array system in lower Martin Slough at high tide on April 27, 2022.

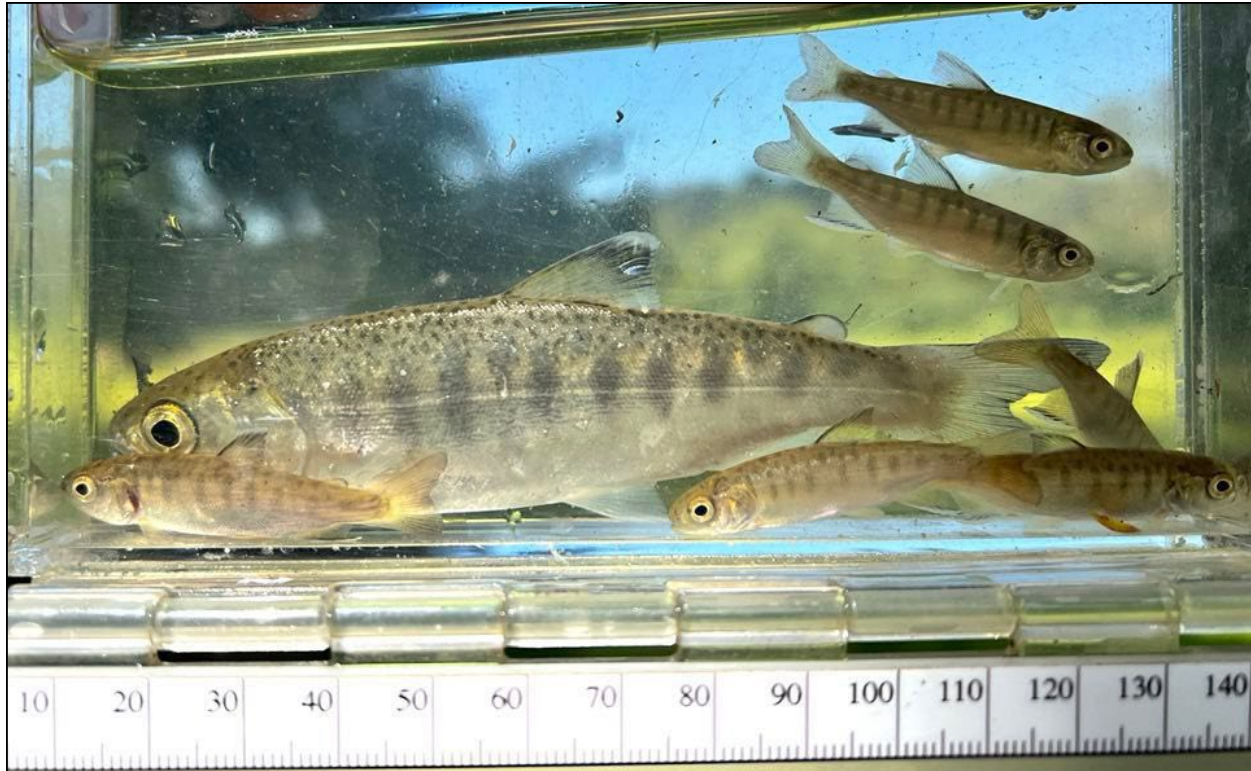
Out of 1,691 juvenile coho salmon caught in 2022, 1,519 (90%) were fry caught in May and June and suspected progeny of adults successfully spawning in Martin Slough. There were 173 captures of age-0 and age-1+ fish that most likely migrated into Martin Slough from the Elk River during the late-fall/early-winter juvenile redistribution period. Most of the newly emerged fry were caught in the main channel, above or near the confluence with the North Fork of Martin Slough. In May 2022, a sub-sample of these fish were measured and weighed and were between 46 and 54 mm in FL and 0.6 to 1.6 g (too small to tag; Figure 7).

Figure 7. Coho salmon smolt and 6 fry caught at the Upper Fairway Drive site on May 19, 2022.
