Martin Slough Enhancement Project 2020 Monitoring Report

December 2020

Martin Slough Enhancement Project 2020 Physical Monitoring Report

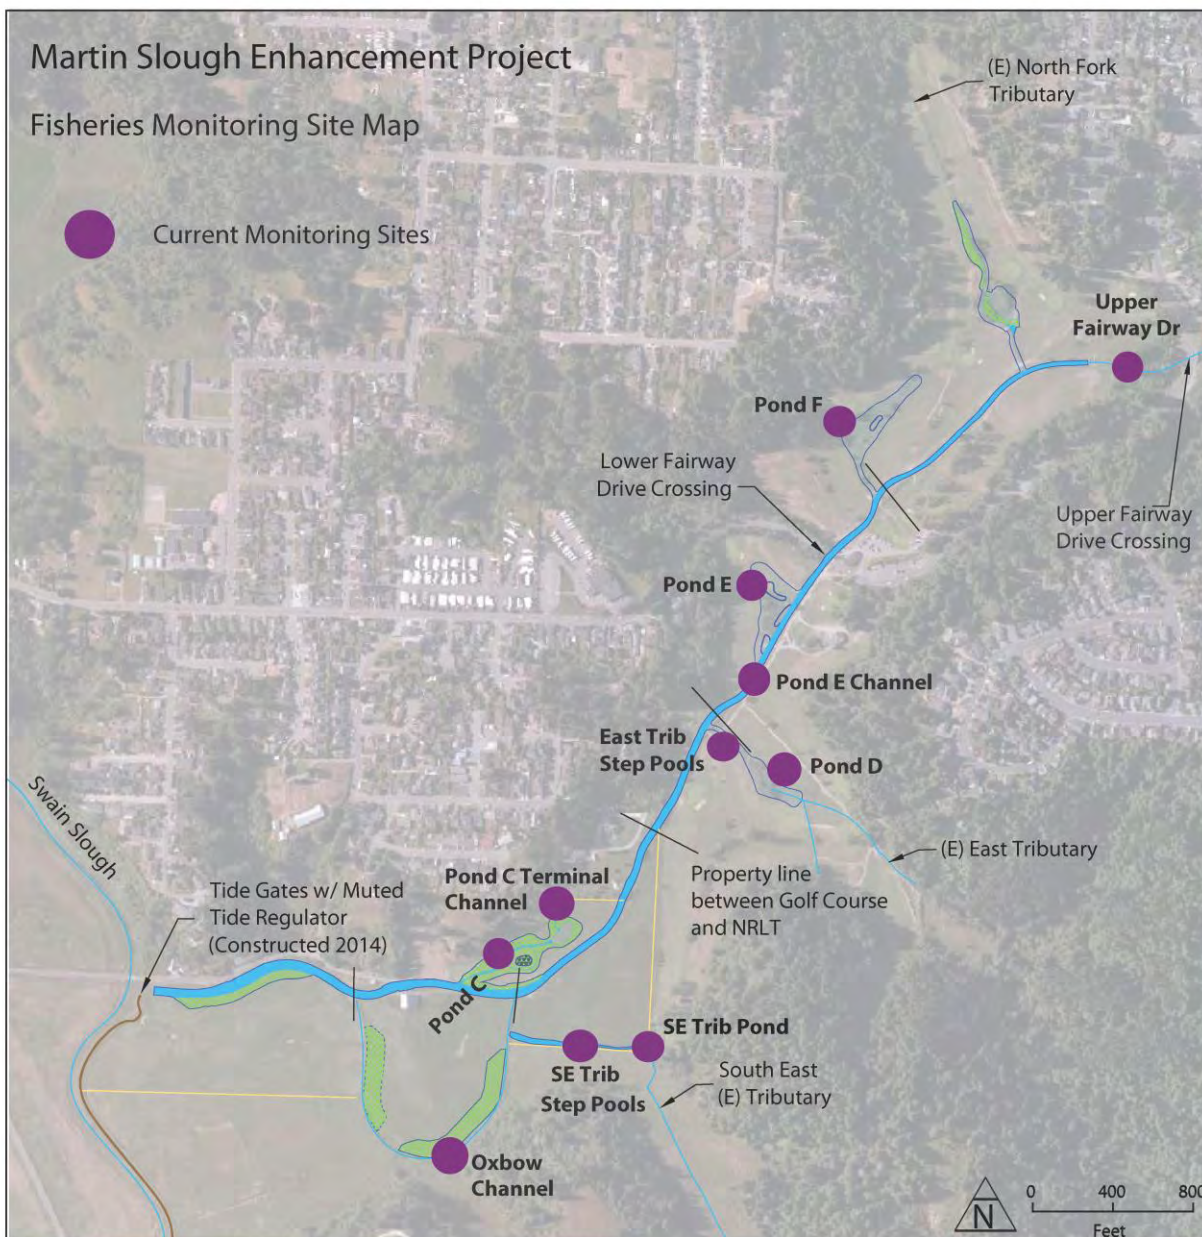
Figure 1. Monitoring Locations in Martin Slough

In 2020, monitoring occurred in eleven locations throughout the project area (Figure 1). On the NRLT property, monitoring took place at Pond C, Pond C Terminal Channel, Southeast (SE) Tributary, Southeast (SE) Tributary Pond, and the Oxbow. On the Eureka Golf Course property, monitoring took place at Pond D, East Tributary Step Pools, Pond E, Pond E Channel (this monitoring site discontinued after 2020 construction), Pond F and Upper Fairway Drive Pool. Monitoring occurred in January, February, March, April, May, October, and December, although not all sites were monitored each month. For example, monitoring in Pond F (which was constructed over the 2020 construction season) began in October (see Table 5 for details on monitoring locations and dates). Water quality monitoring occurred during each monitoring event (Appendix C).

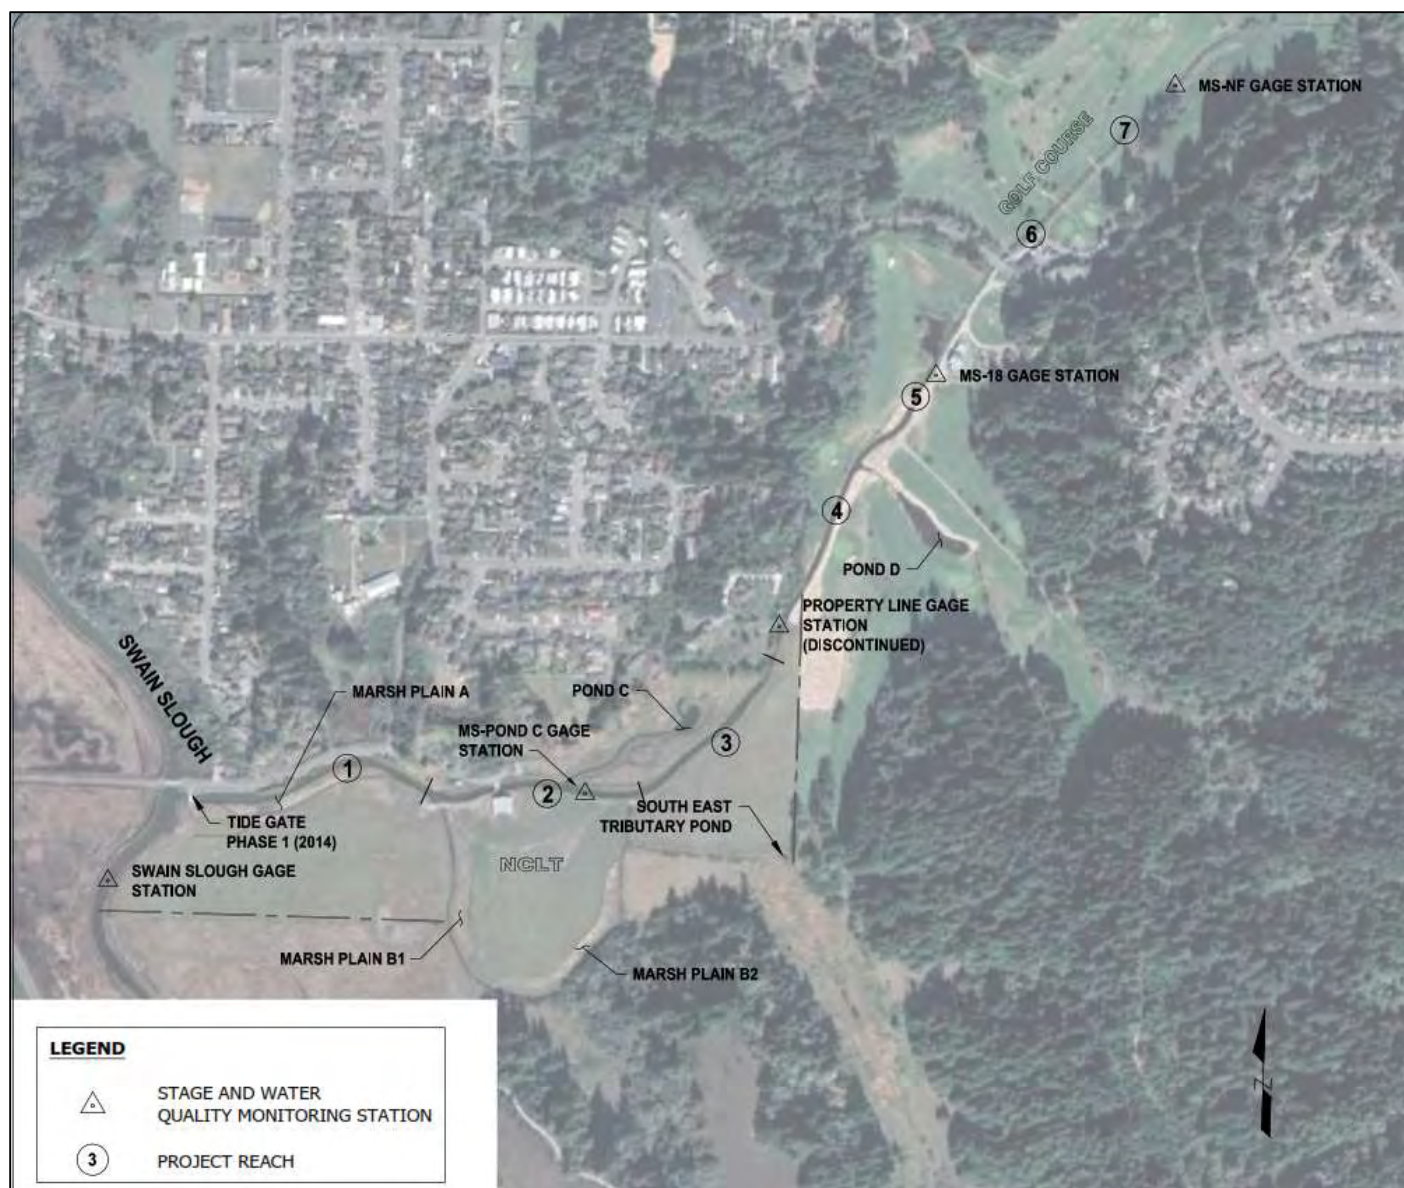
Figure 2. Overview of Phases 1, 2, and 3, and location of stage and water quality monitoring stations (image from Google Earth, Oct. 2019).

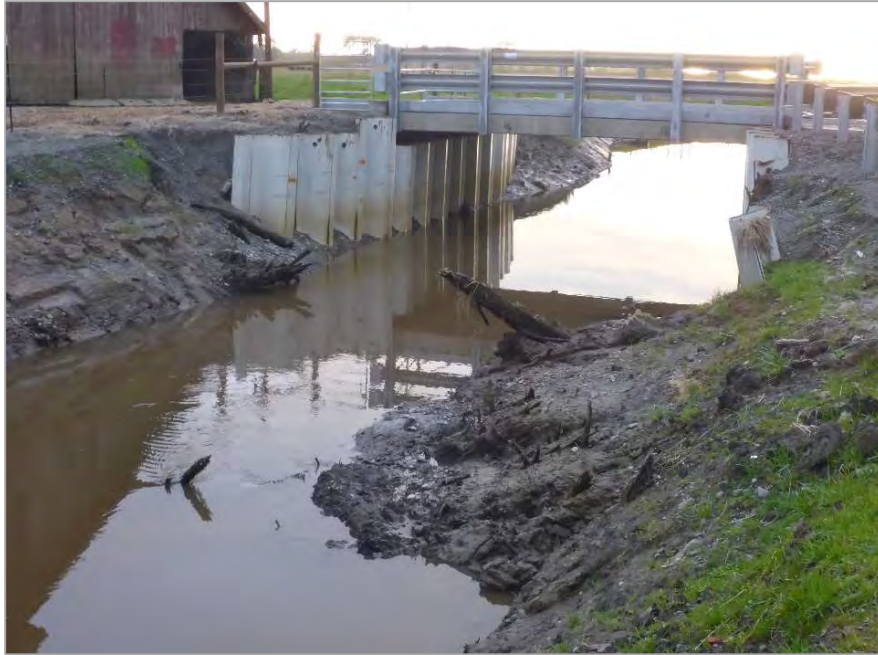
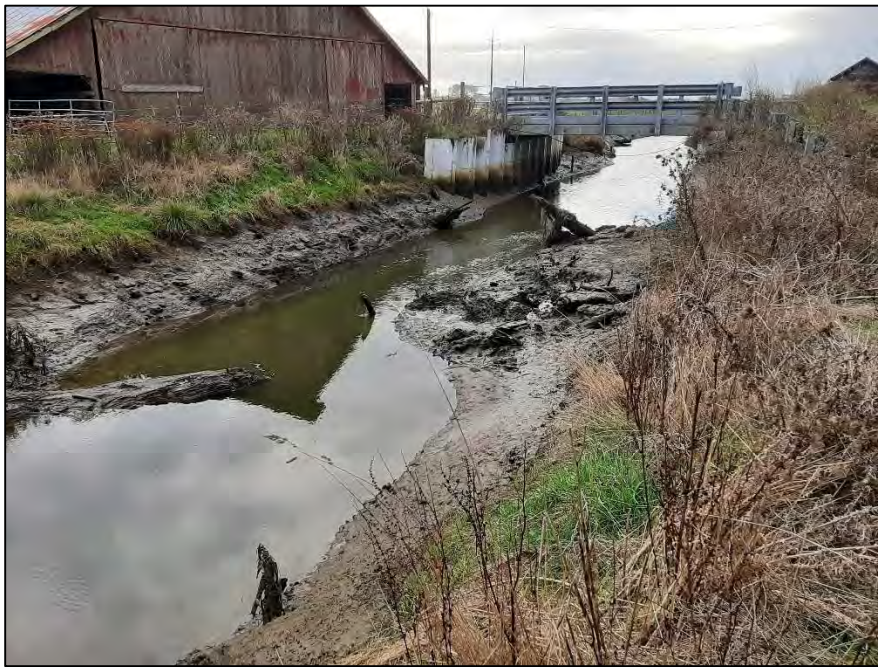
A high spot in the channel caused by a slumping bank was identified during the Year 1 survey of Phase 2. This is located immediately upstream of the new bridge and sheet pile retaining wall at the NRLT barn. A section of the right bank appears to be slumping into the channel when observed at low tide, and there are numerous seeps emerging from the adjacent hillside (Figure 3). High groundwater along the base of the adjoining hillslope appears to be driving the instability.

Figure 3. Bank slumping along the right side of the channel immediately upstream of the new bridge and sheet pile retaining wall, as seen (a) in December 2019 and (b) in December 2020 at low tide.

An area of potential concern arising out of the water year 2019 monitoring is associated with the high point identified along the thalweg profile around Station 14+00 due to a slumping bank associated with high groundwater and saturated soils close to the base of the adjoining hillslope. Material may be continuing to slump at this location, but currently is not significantly constricting the channel or influencing the tidal amplitude. Additional channel constriction could cause upstream flooding and channel sedimentation, and would limit upstream tidal influences. The project manager and project engineer should inspect this site after high flow events to detect if any additional slumping occurs, and if material is being transported. This reach is slated to be resurveyed as part of next topographic monitoring activities in summer of 2021.

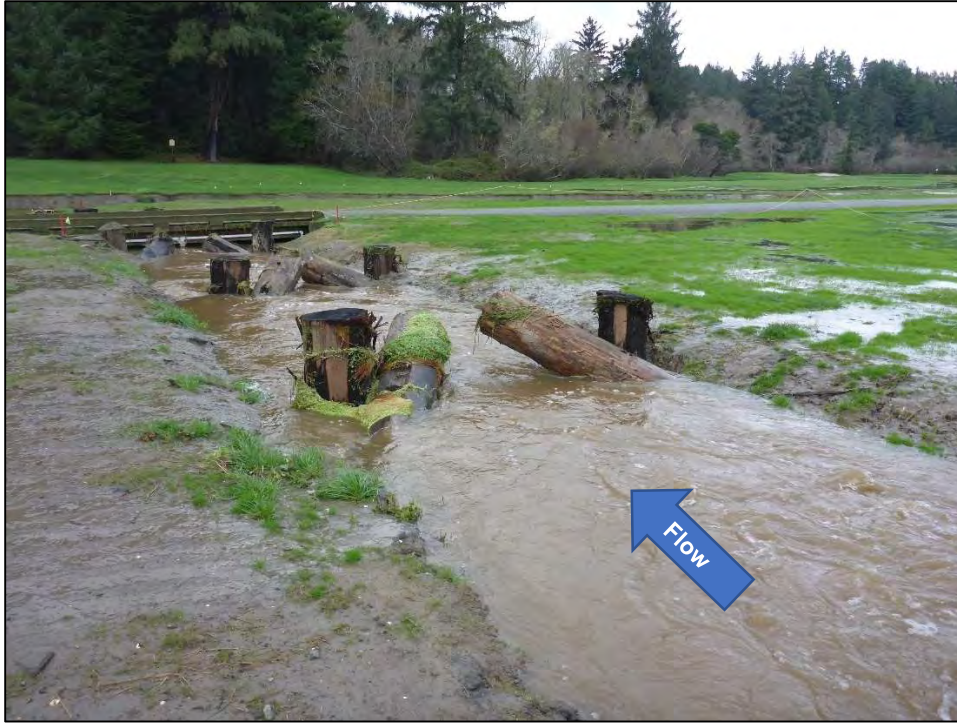
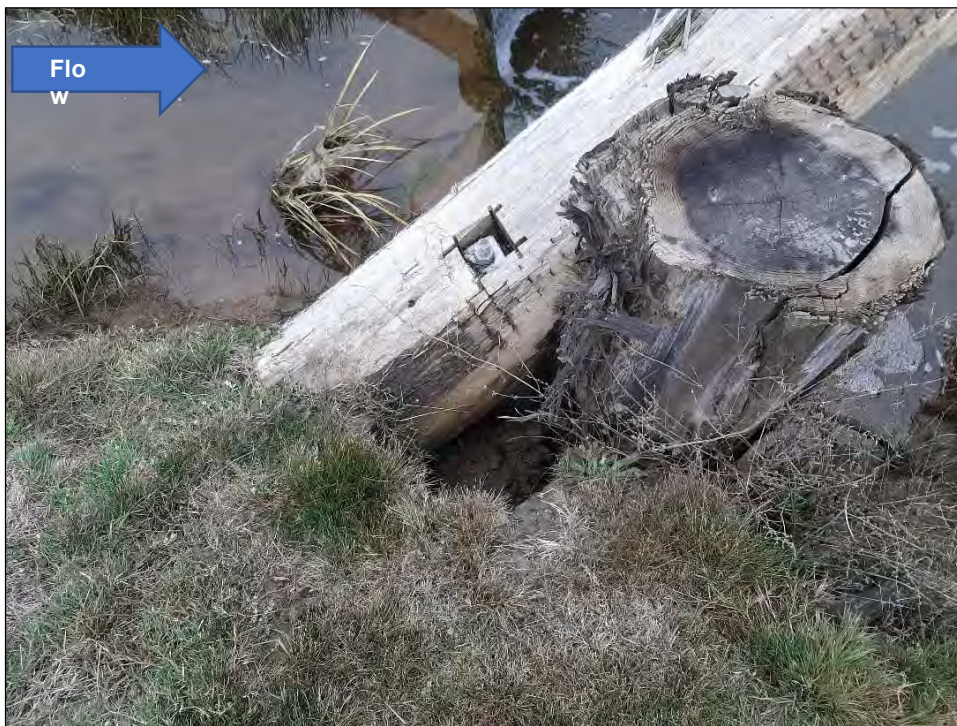
The large wood structures were inspected on December 10, 2020 to ensure they were stable and functioning as intended. All structures (Log Cover Structures, Rood Wad Deflectors, and Root Wad Habitat Structures, Log Constrictors, Log Weirs) appeared stable and show no signs of shifting since constructed. Wood features located in the middle of Pond D were observed from the shore. All anchor points looked sound. The only item of note was erosion visible against pile logs associated with the log weirs between Pond D and the mainstem Marin Slough channel (Figure 4). The erosion is along the back (downstream) side of the training logs that sit on top of the weir logs. This occurred during high flows on December 22, 2019, when water flanked the training logs and eroded the relatively loose and unvegetated bank material. This is a common location for erosion to develop during the first year following construction due to difficulty compacting the soils in this area and the lack of well-established vegetation. The voids can be filled and compacted with soil or rock. Brush baffles combined live stake and other plantings could within the placed fill to slow water velocities at these vulnerable locations.

Figure 4. On December 22, 2019 (a) high flows overtopped the banks at Pond D and the channel draining the pond into Martin Slough, causing flow to flank the log weirs and (b) causing scour pockets behind the training logs located on top of the weir logs.
