Martin Slough Enhancement Project 2021 Monitoring Report

March 2022

Natural Resources Services A Division of Redwood Community Action Agency 904 G Street Eureka, CA 95501

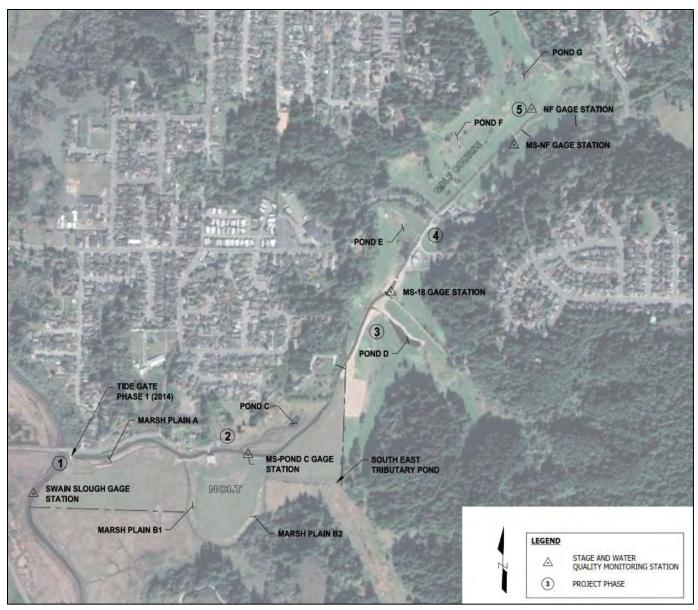
Figure 2. Overview of Phases 1 through 5, and location of stage and water quality monitoring stations (image from Google Earth, Oct. 2019).

The following hydrologic monitoring stations were maintained and regularly monitored during water year 2021: Swain Slough, MS-Pond C (NRLT), MS-18 (golf course), MS-NF (golf course) (see Appendix D, Figure 2). For more information on installation dates, and removal for construction or repair, see Appendix D, section 2.2.1 Water Level Monitoring.

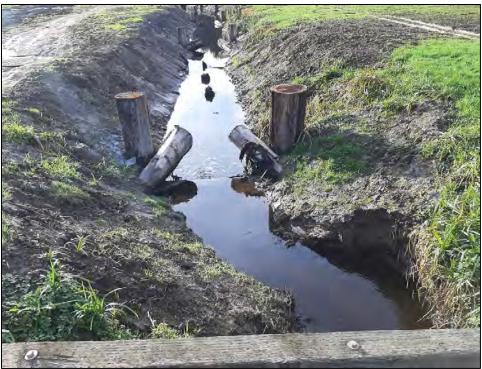
The channel alignment at the upstream end of the project is causing some scour along the right bank of the upstream most log weir (**Figure 4**). This condition may improve as the upstream channel adjusts to the downstream weir elevations. This area should be monitored and may requires some minor bank stabilization measures.

Figure 4. Upstream of the last weir where the project transitions back to the undisturbed channel. Alignment of the channel is creating some bank scour along the right bank.

In addition to the two high spots in the mainstem discussed earlier, MLA that the channel alignment at the upstream end of the project is causing some scour along the right bank of the upstream most log weir. This condition may improve as the upstream channel adjusts to the downstream weir elevations. This area should be monitored and may requires some minor bank stabilization measures.

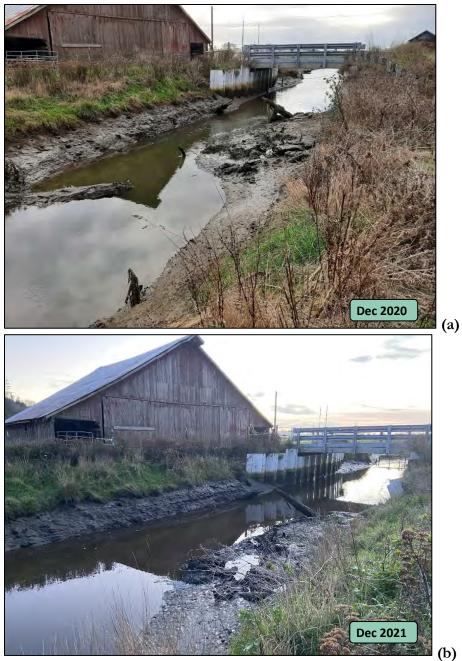
Figure 5. Bank slumping along the right side of the channel immediately upstream of the new bridge and sheet pile retaining wall, as seen (a) in December 2020 and (b) in December 2021 at low tide.

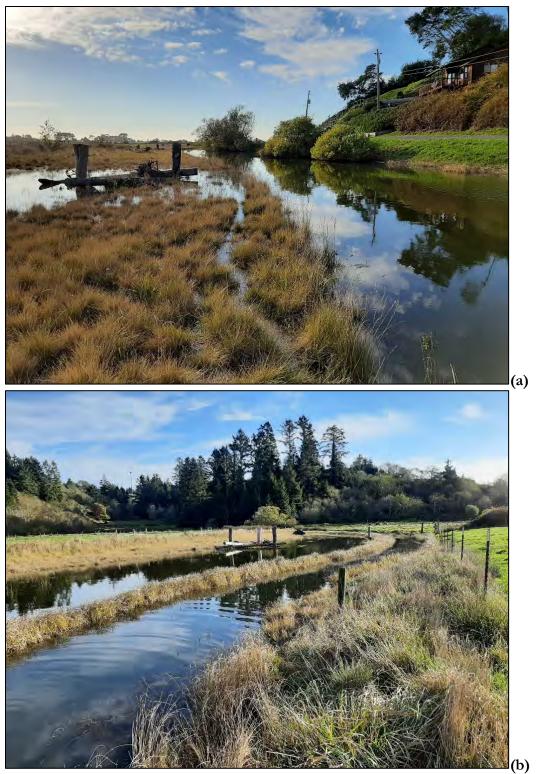
Figure 6. Marshplain A (a) and Marshplain B (b) as seen in November 2021 during high tide.

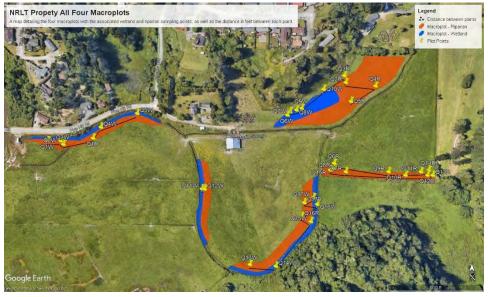
Map 1. Represents the four Macroplots on the NRLT property, distinguishing the riparian and wetland zones, sampling plot locations, and the distance between plots.

The establishment of fixed monitoring macroplots allows for a direct qualitative comparison from year to year to highlight vegetation changes and distinguish trends. Four Macroplots were established in the first year of monitoring in Summer 2020: Marsh Plain A, Oxbow, Pond C, and Southeast Tributary (SE Tributary), as shown in Map 1.

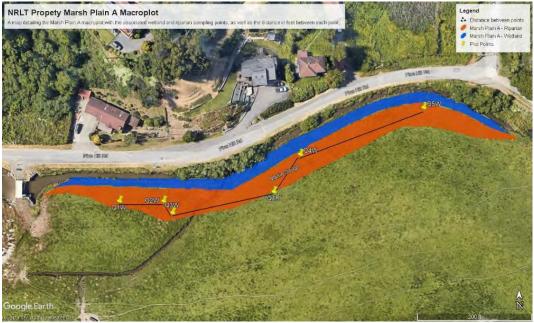
Map 2. Represents the entirety of the Marsh Plain A Macroplot with a distinction between the riparian and wetland zones, as well as the sampling point locations and distance between plots.

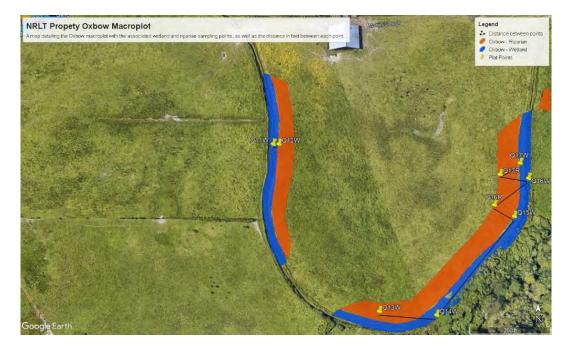
Map 3. Represents the entirety of the Oxbow Macroplot with a distinction between the riparian and wetland zones, as well as the sampling point locations, and distance between plots.

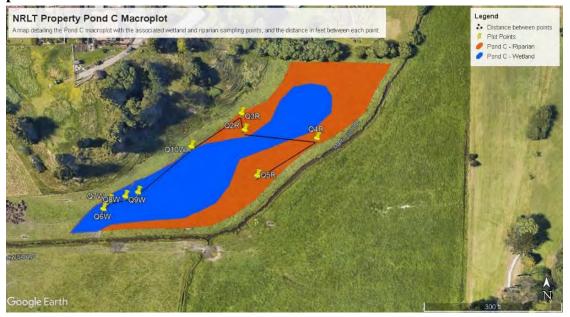
Map 4. Represents the entirety of the Pond C Macroplot with a distinction between the riparian and wetland zones, as well as the sampling point locations, and distance between plots.

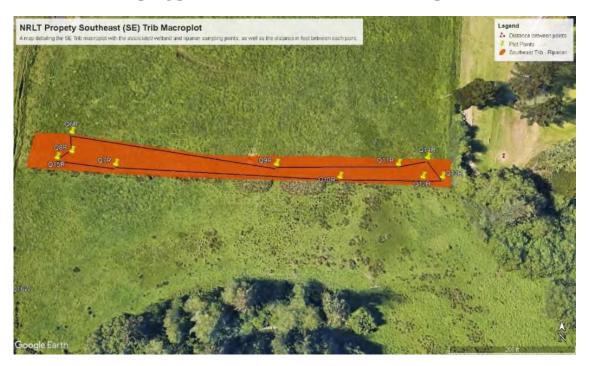
Map 5. Represents the entirety of the SE Tributary Macroplot showing the riparian zone, as well as the sampling point locations, and distance between plots.
